David A Toole Construction Inspections LLC
114 Briggs Ave.
davidatoole@bellsouth.net
North Augusta, SC 29841
(803) 221-6836

Report #: Munn412009

21 Plantation Ct.

North Augusta, SC 29841

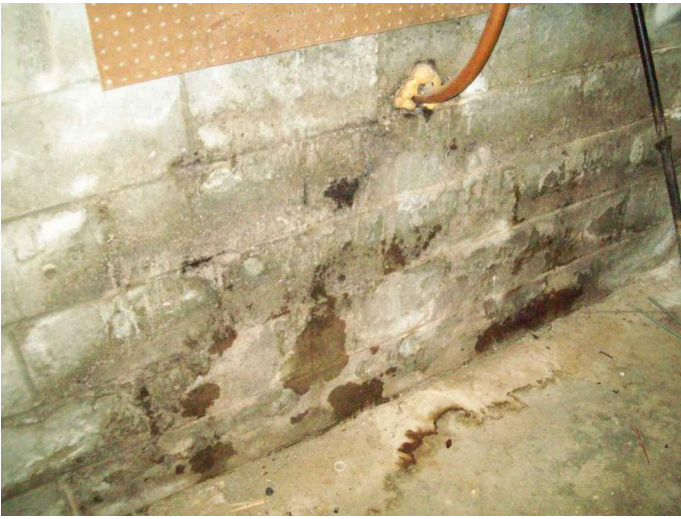
Signs of water intrusion at front foundation wall

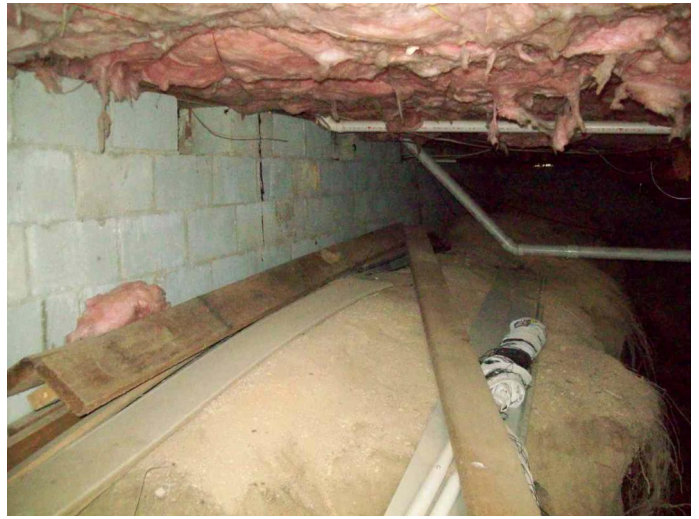
Wood to earth contact in crawl space.

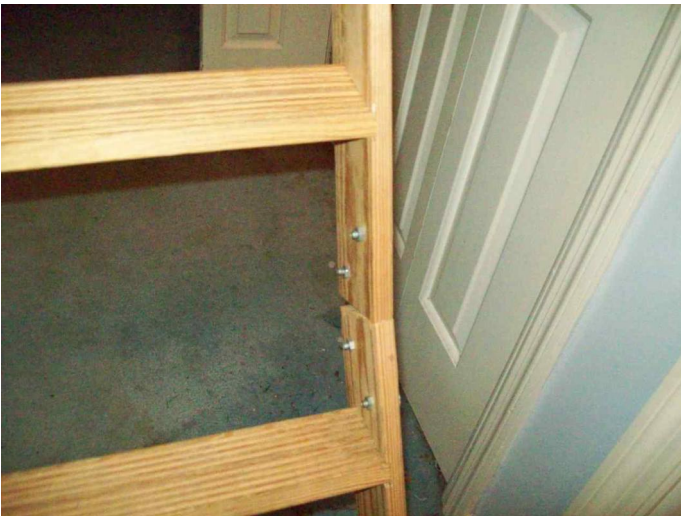
Attic pull down stairs the legs need to be cut to proper length

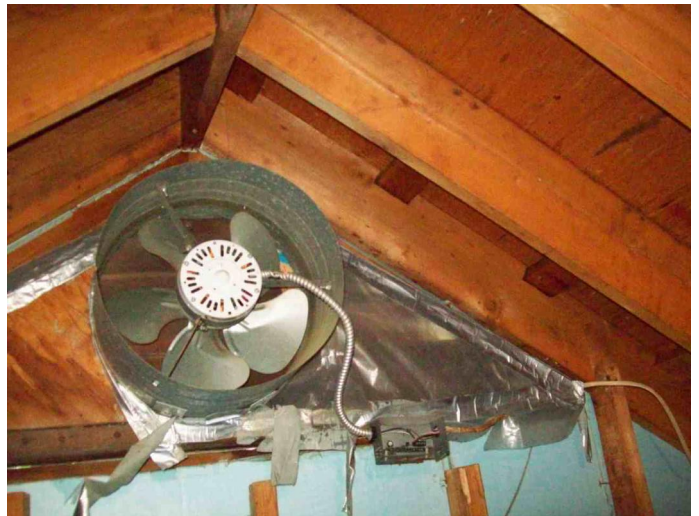
Remove gable end vent fans.

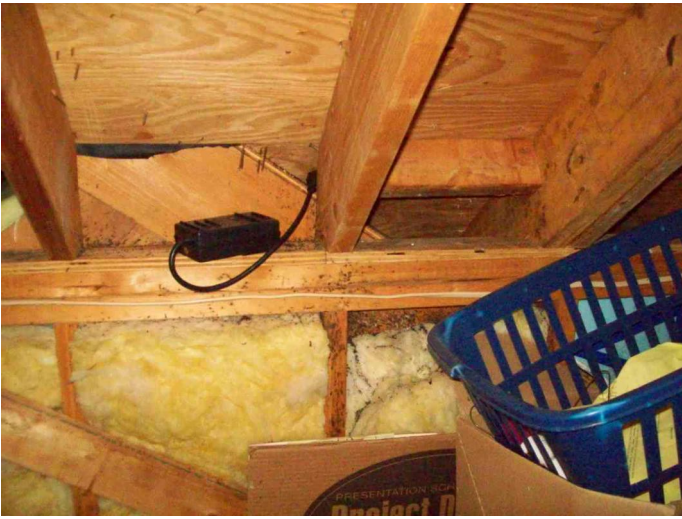
Evidence of roach infestation in attic area, just above and left of attic stairs.
